**RE: PRELIMINARY RESOURCE ASSESSMENT
PROPOSED SAND EXTRACTION – CABBAGE TREE ROAD, WILLIAMTOWN**

Please find enclosed our Preliminary Resource Assessment report for the proposed Sand Extraction Site located off Cabbage Tree Road, Williamtown.

Qualtest Laboratory NSW Pty Ltd (Qualtest) is pleased to present this report on behalf of Williamtown Sand Syndicate Pty Ltd for the proposed Cabbage Tree Road sand extraction pit, to be located off Cabbage Tree Road, Williamtown.

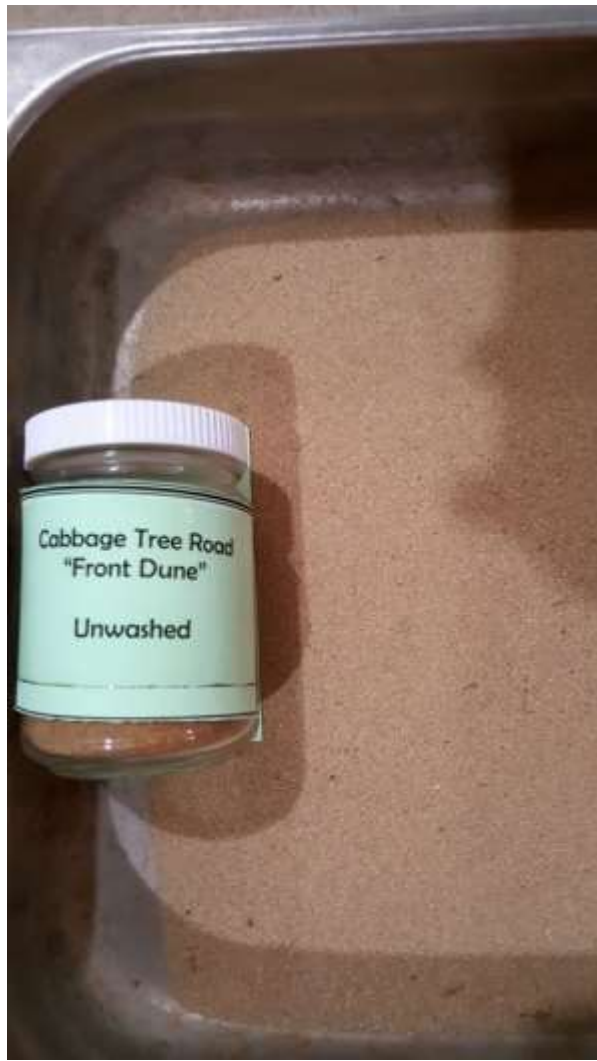
Site Photograph 1A: Before Washing

S01 – Cabbage Tree Road – “Front Dune”

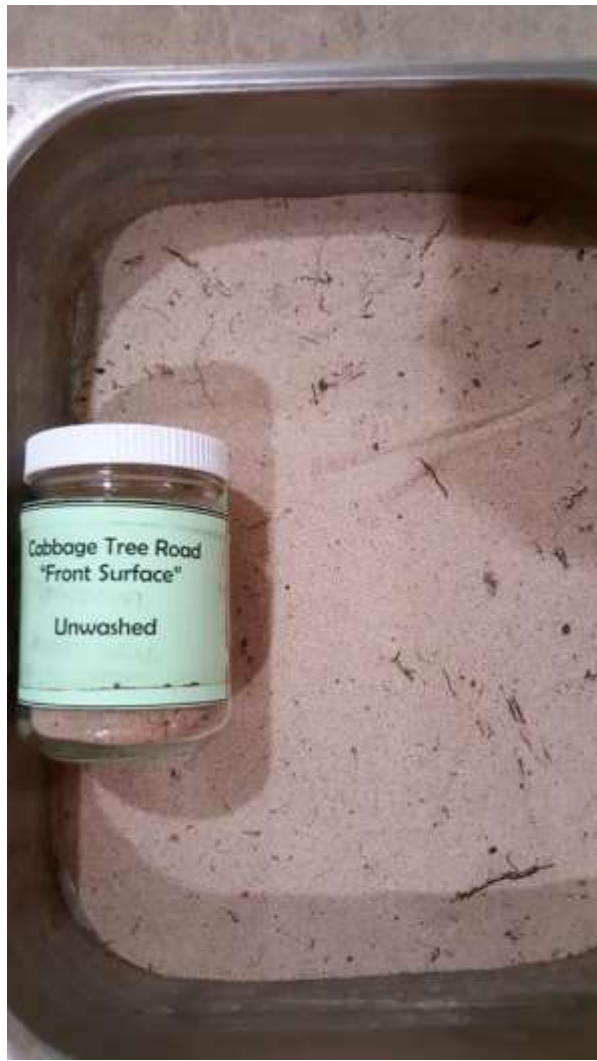
Site Photograph 2A: Before Washing

S02 – Cabbage Tree Road – “Front Dune Surface”

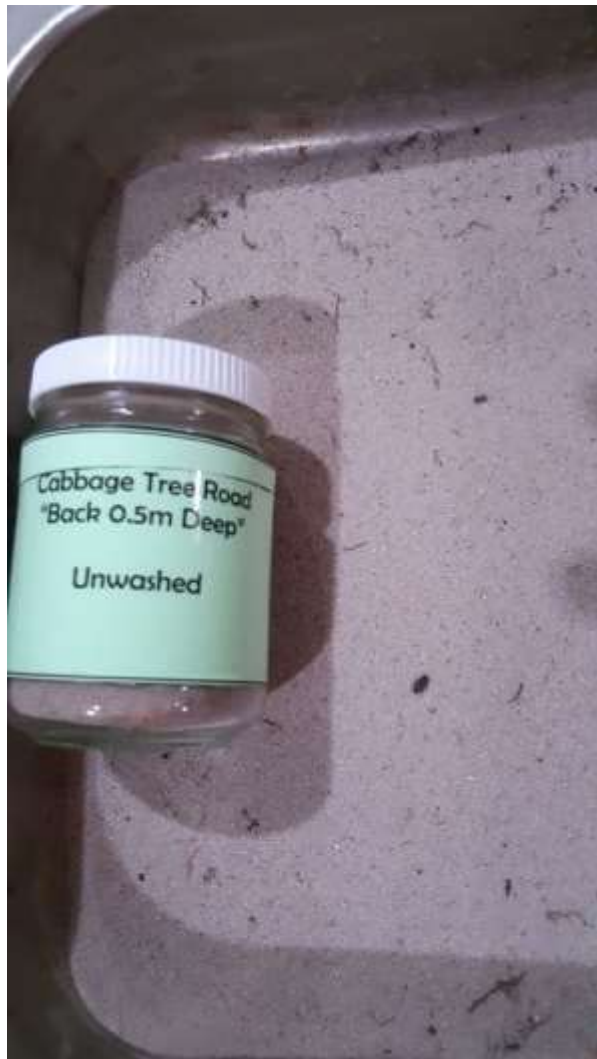
Site Photograph 3A: Before Washing

S03 – Cabbage Tree Road – “Back Dune 0.5m Deep”

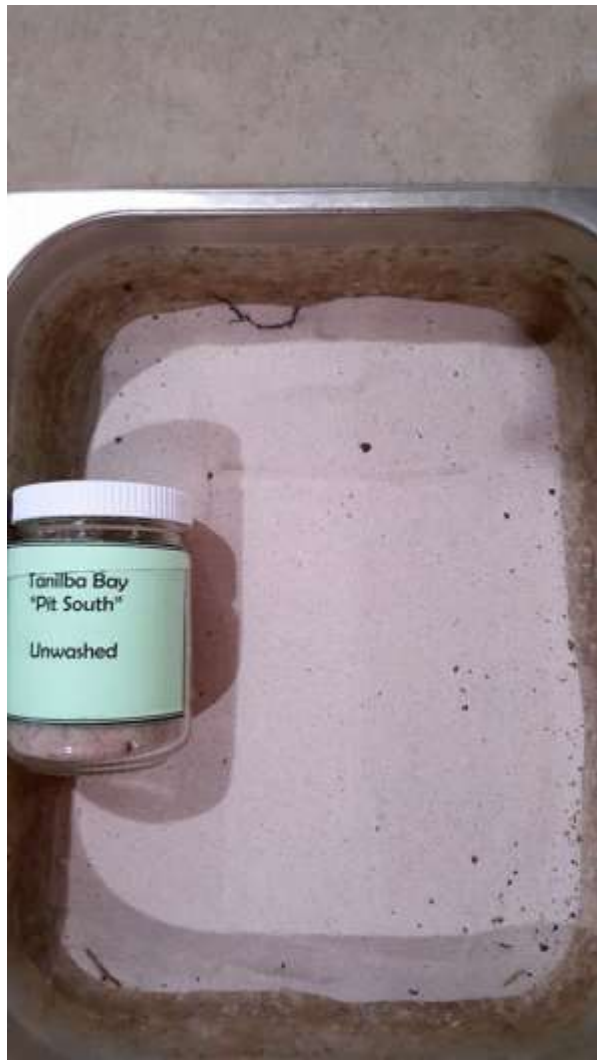
Site Photograph 4A: Before Washing

S04 – Tanilba Bay – “Pit South”

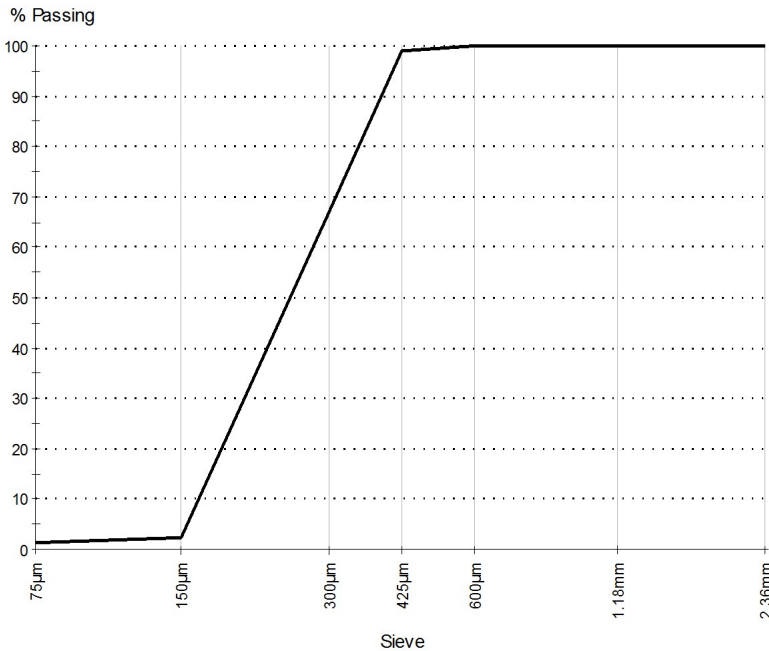
Particle Size Distribution

Method: AS 1289.3.6.1

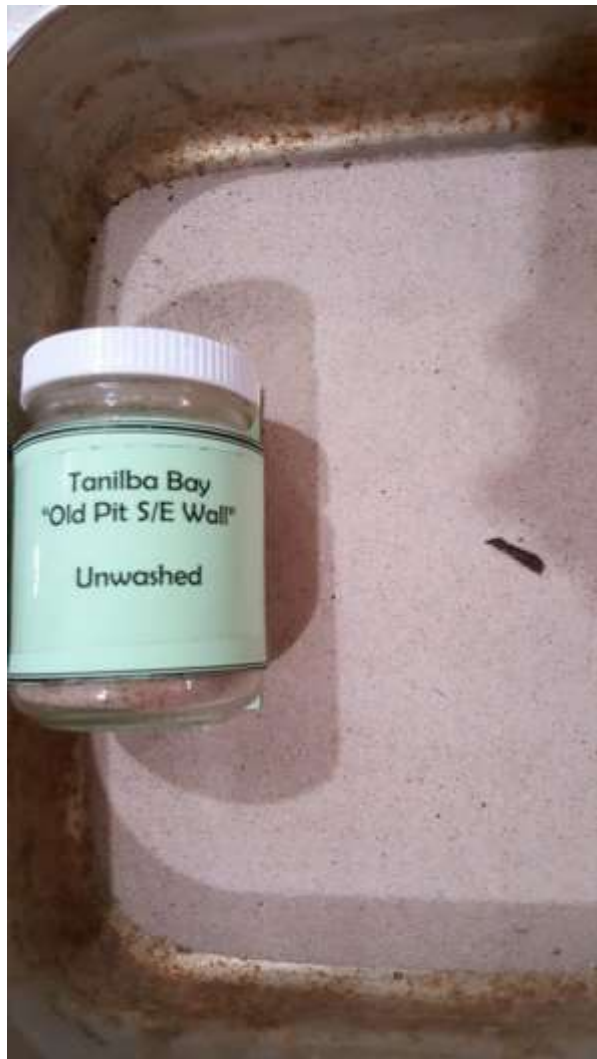
Site Photograph 5A: Before Washing

S05 – Tanilba Bay – “Old Pit Southeast wall”

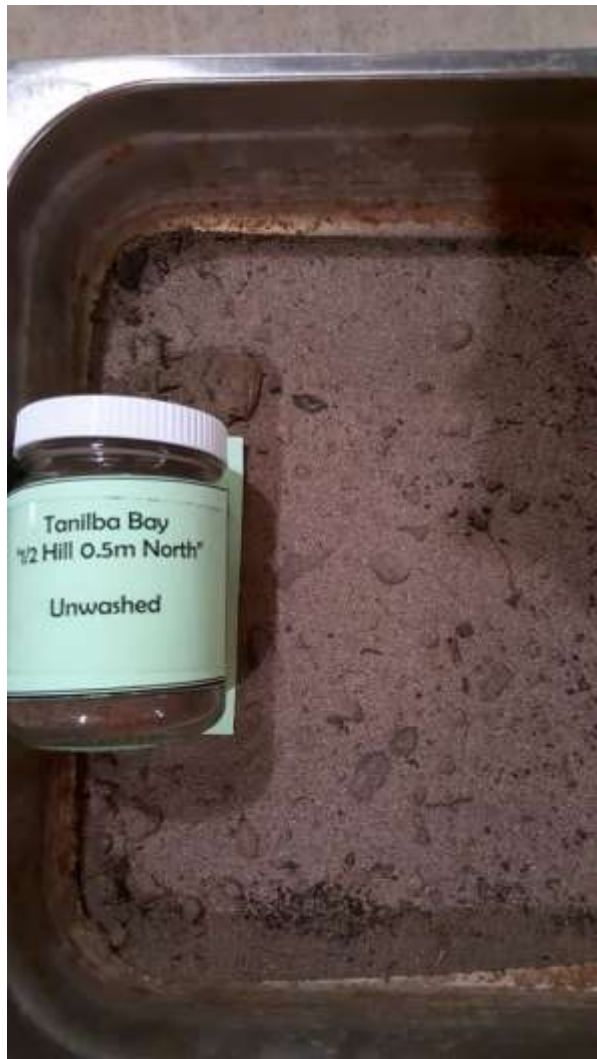
Site Photograph 6A: Before Washing

S06 – Tanilba Bay – “Half Hill 0.5m North”

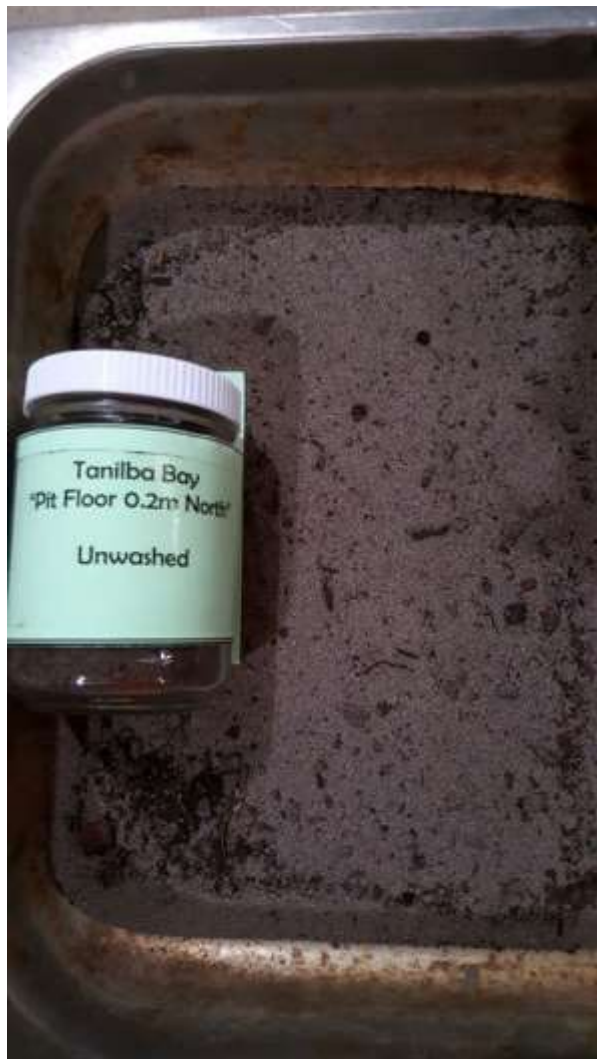
Site Photograph 7A: Before washing

S07 – Tanilba Bay – “Pit Floor 0.2m North”

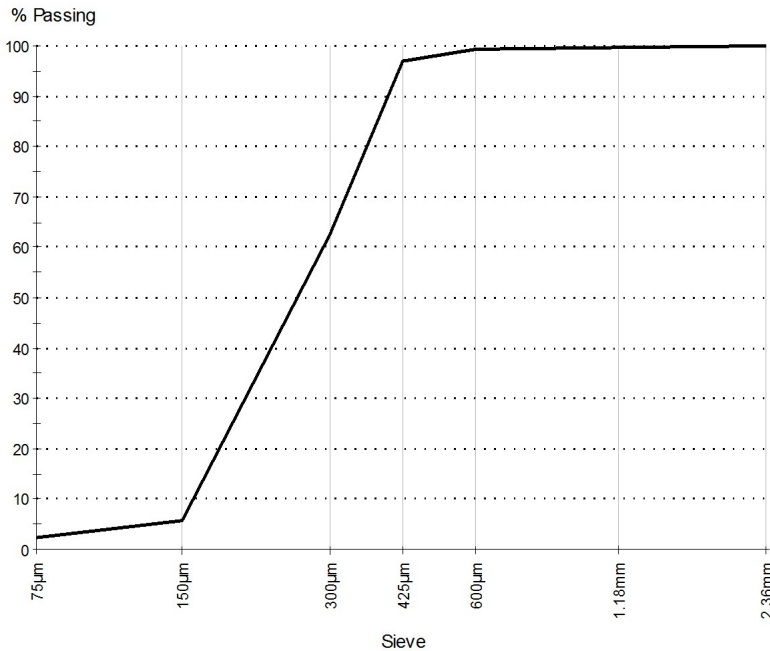
Particle Size Distribution

Method: AS 1289.3.6.1

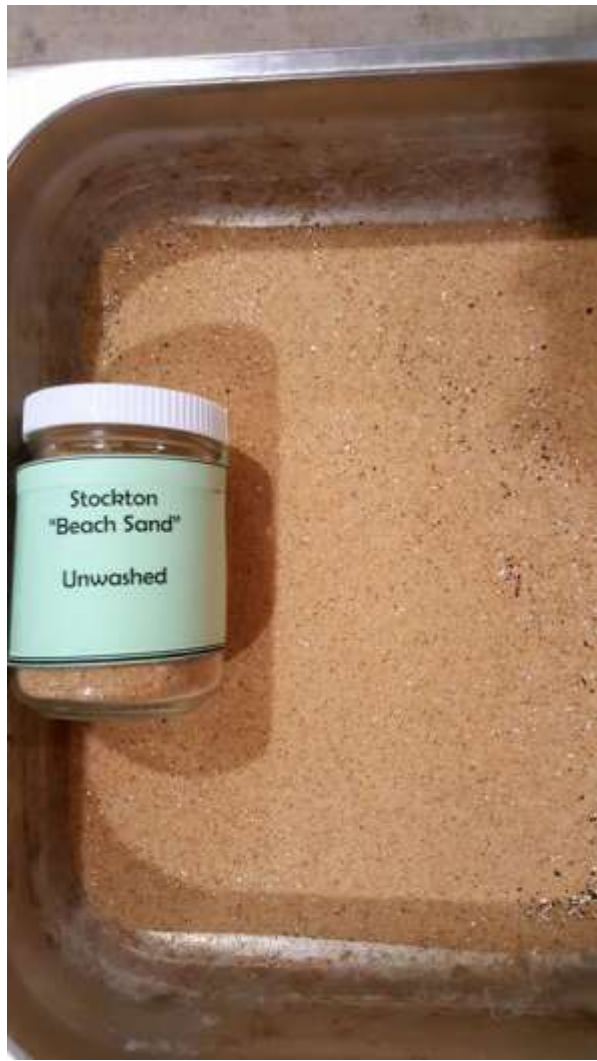
Site Photograph 8A: Before Washing

S08 – “Stockton Beach Sand”

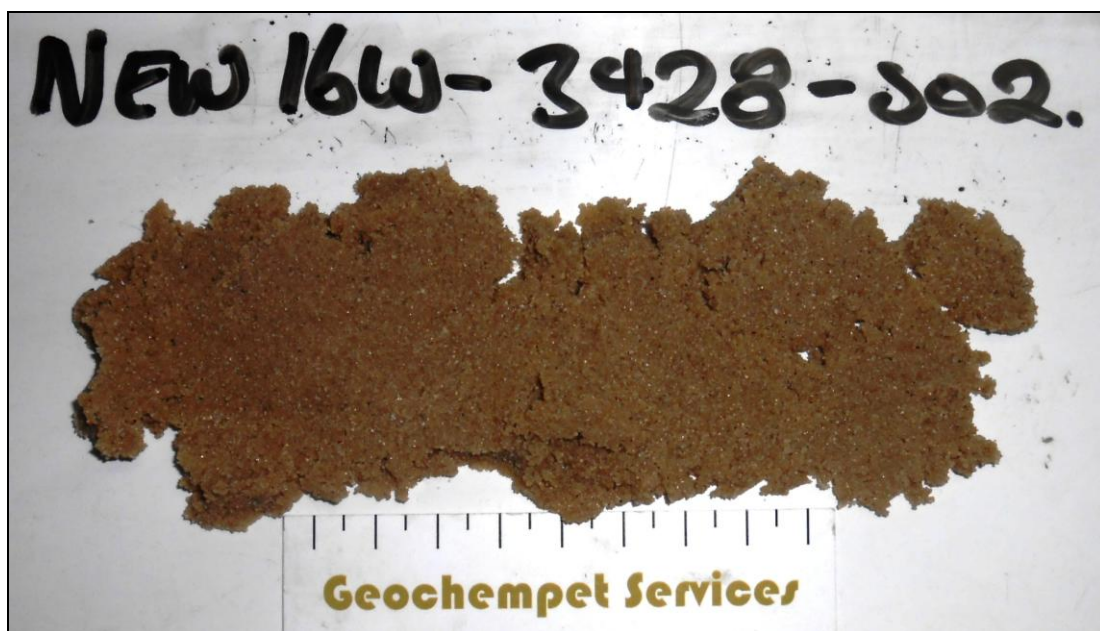
The sample consisted of about 5 kg of brown sand, composed largely of subangular to less commonly subrounded quartz.

Figure 1. Digital image of sub-sample of supplied sand

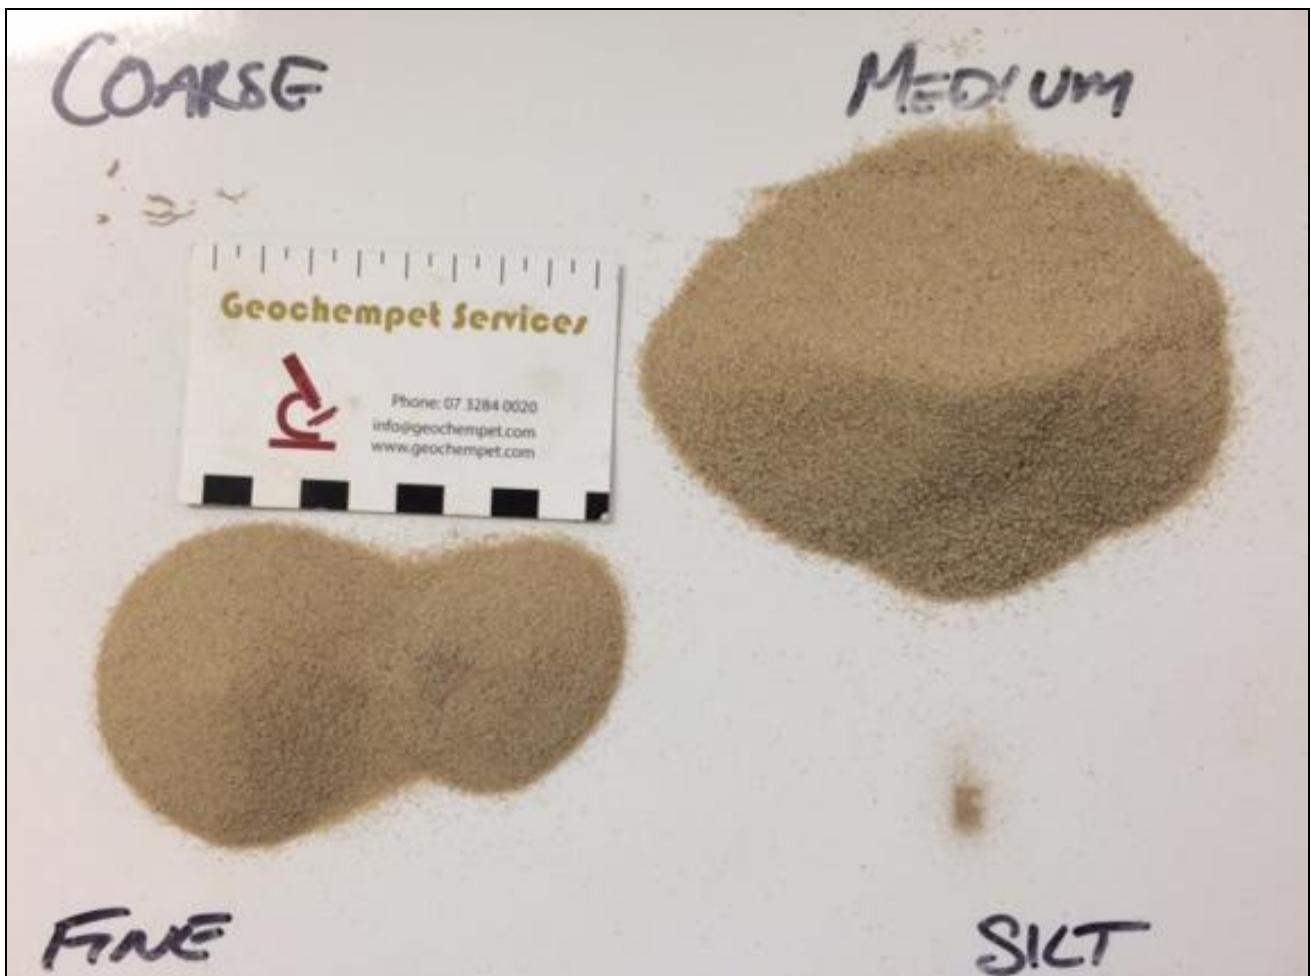
The coarse fraction consisted entirely of plant matter.

When a subsample was swirled with water in a glass beaker, there was a light suspension of material indicating the presence of minor clay and silt.

Figure 2. Digital image of sieve fractions

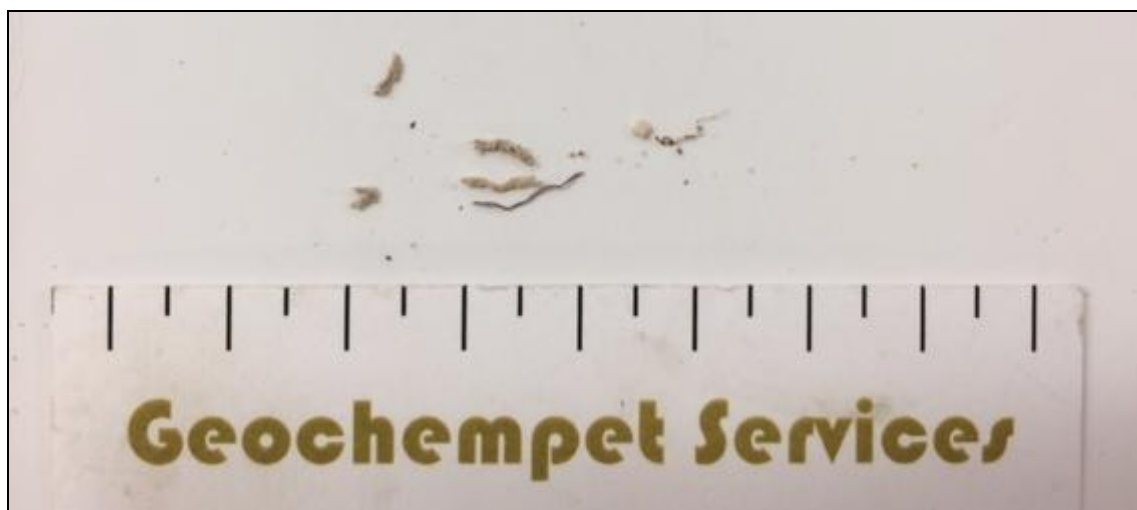
Figure 3: Image of the coarse fraction showing plant fragments

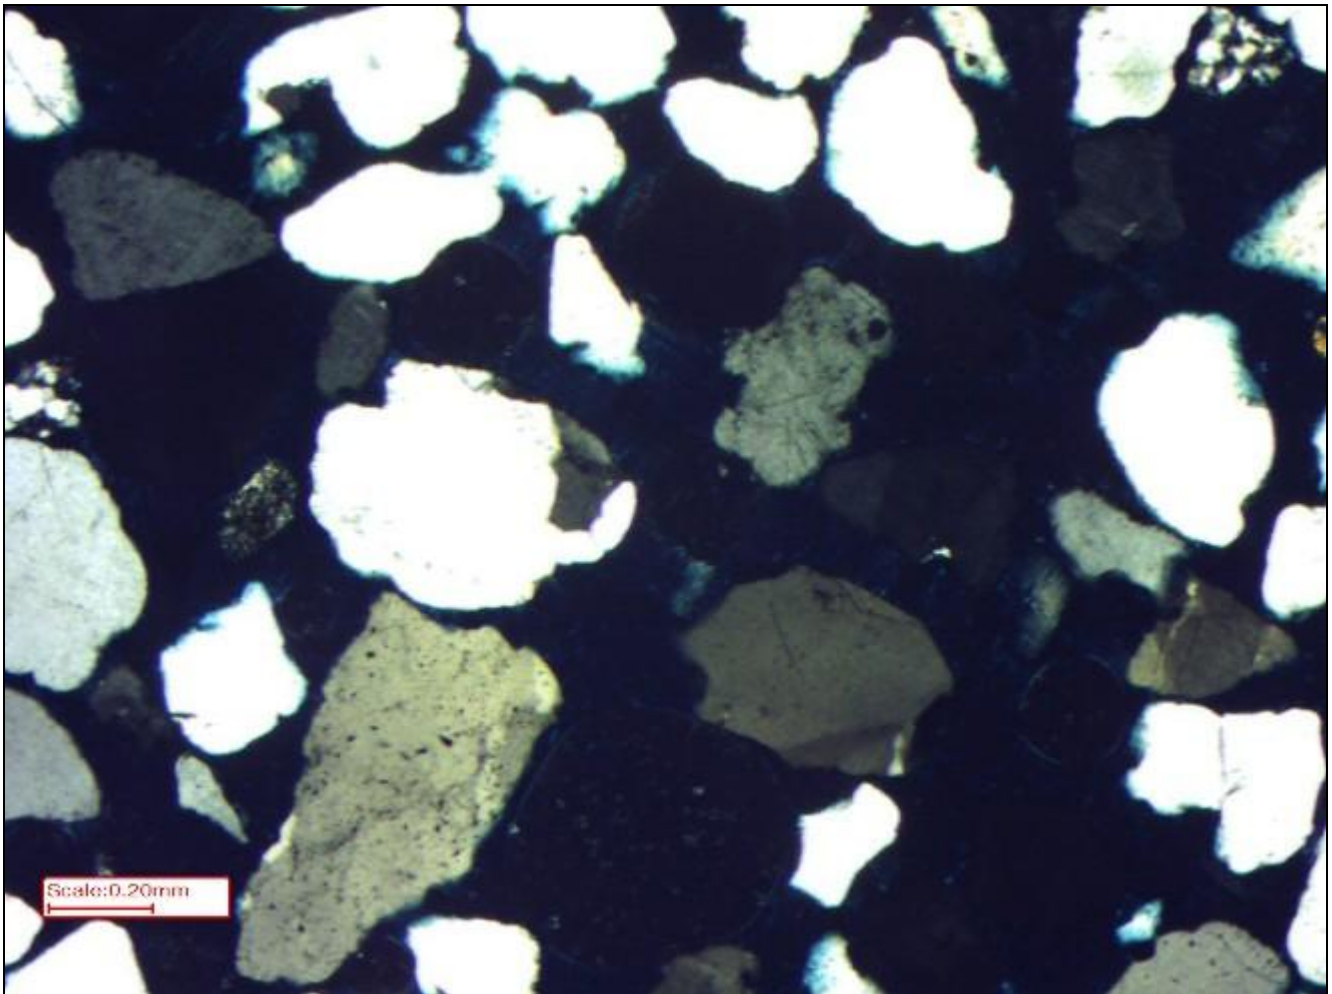
Figure 4. Microscopic image of slide from concrete sand – bland sand sample. Image is dominated by sub-rounded quartz grains with a small number of other lithic clast including acid-volcanic clasts and chert clasts.

The sand as a whole is predicted to have **potential for mild or slow deleterious alkali-silica reactivity in concrete**. It carries about 2% of cherty or finely microcrystalline quartz and 21% of moderately stained quartz and 1% heavily strained quartz.

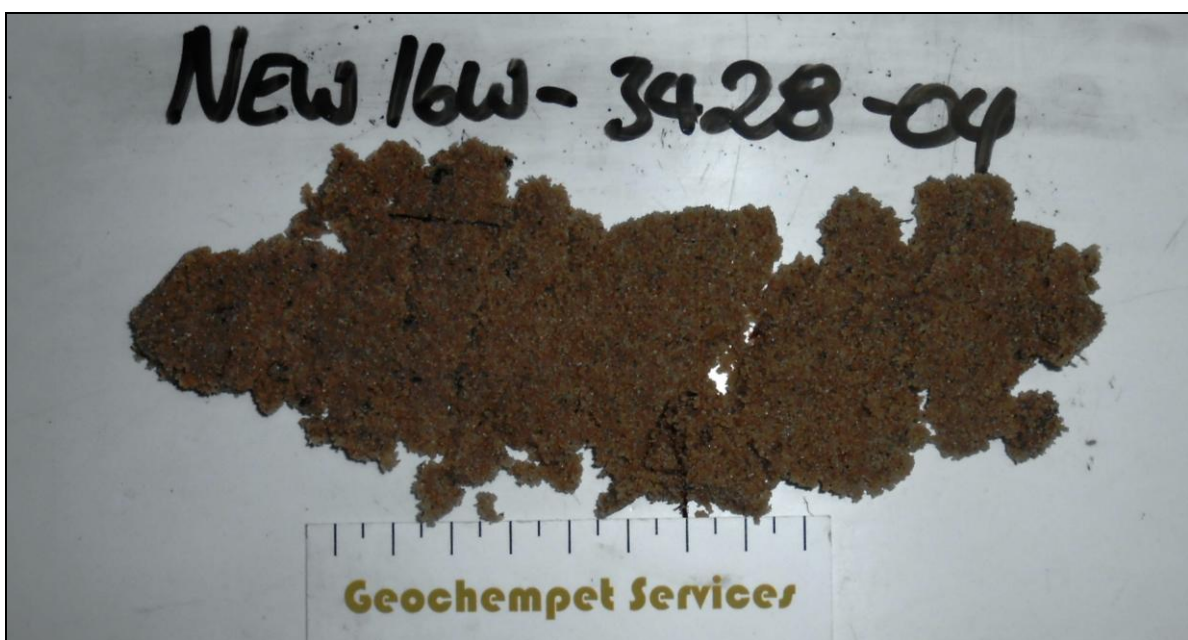
The sample consisted of about 5 kg of brown sand, composed largely of subangular to less commonly subrounded quartz.

Figure 1. Digital image of sub-sample of supplied sand

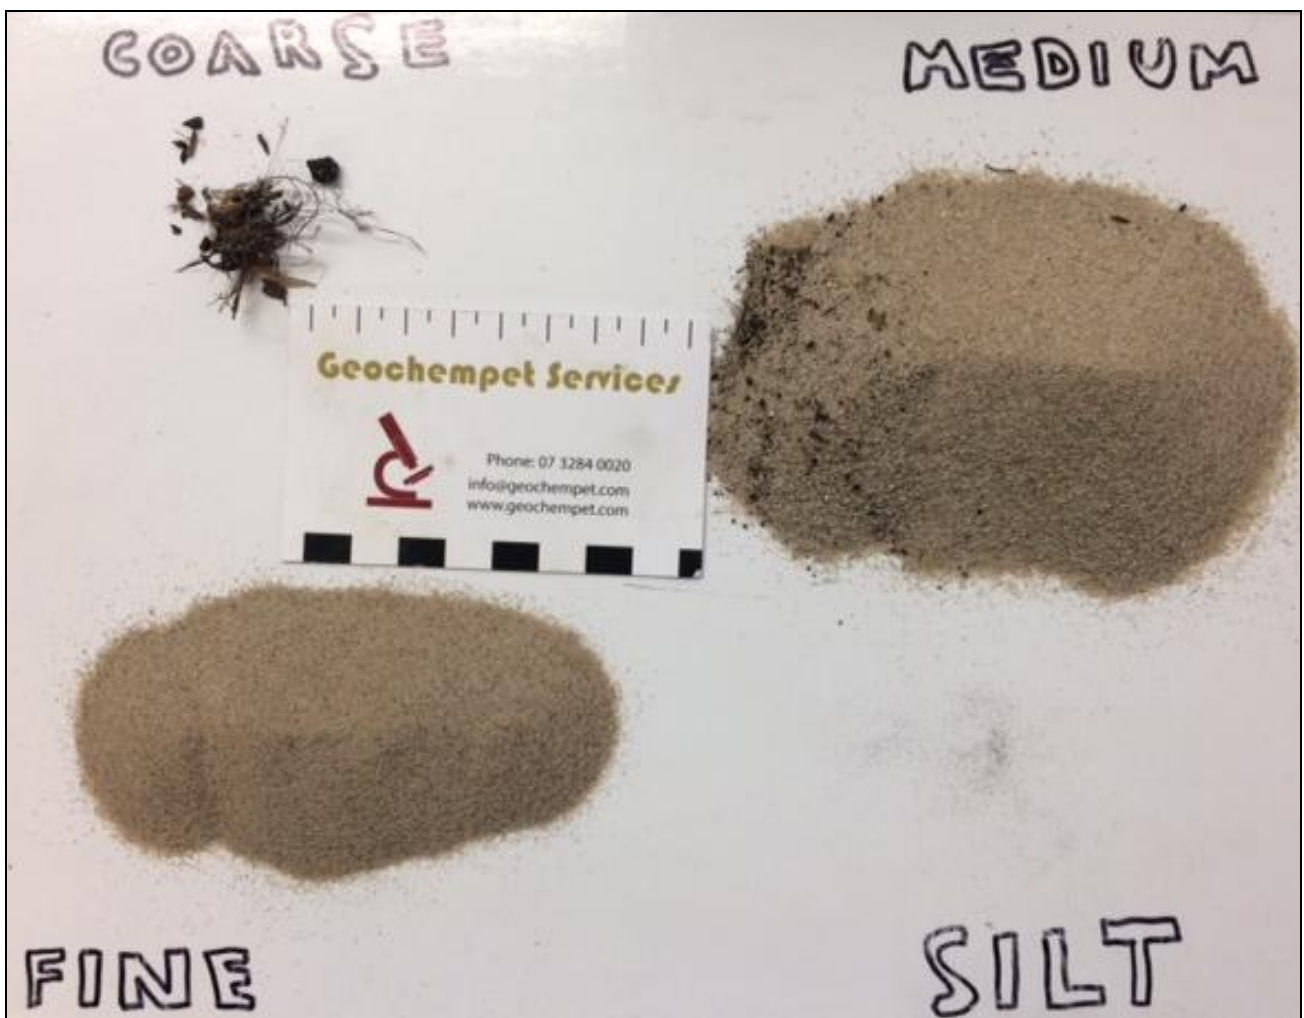
The coarse fraction consisted of a mixture of plant material and charcoal.

When a subsample was swirled with water in a glass beaker, there was a light suspension of material indicating the presence of minor clay and silt.

Figure 2. Digital image of sieve fractions

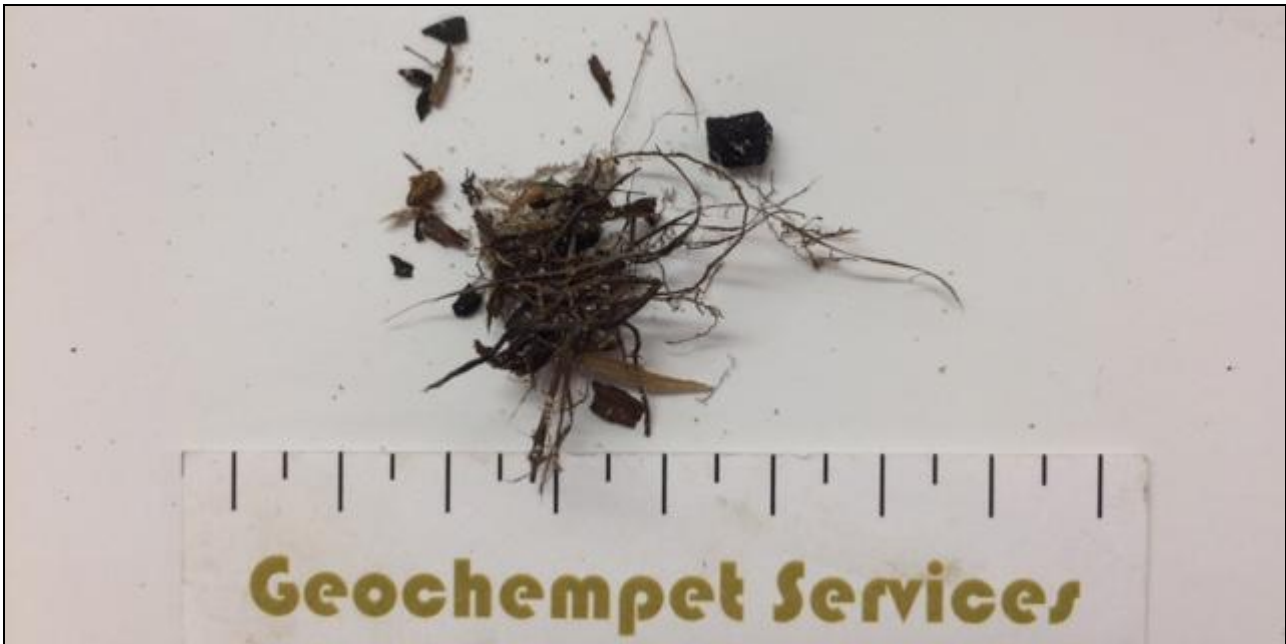
Figure 3: Image of the coarse fraction showing plant fragments and charcoal.
