# Williamtown Sand Syndicate – Per- and Polyfluoroalkyl Substances Annual Risk Review

398 Cabbage Tree Road, Williamtown, New South Wales, 2318

25003700.001A

20 March 2025

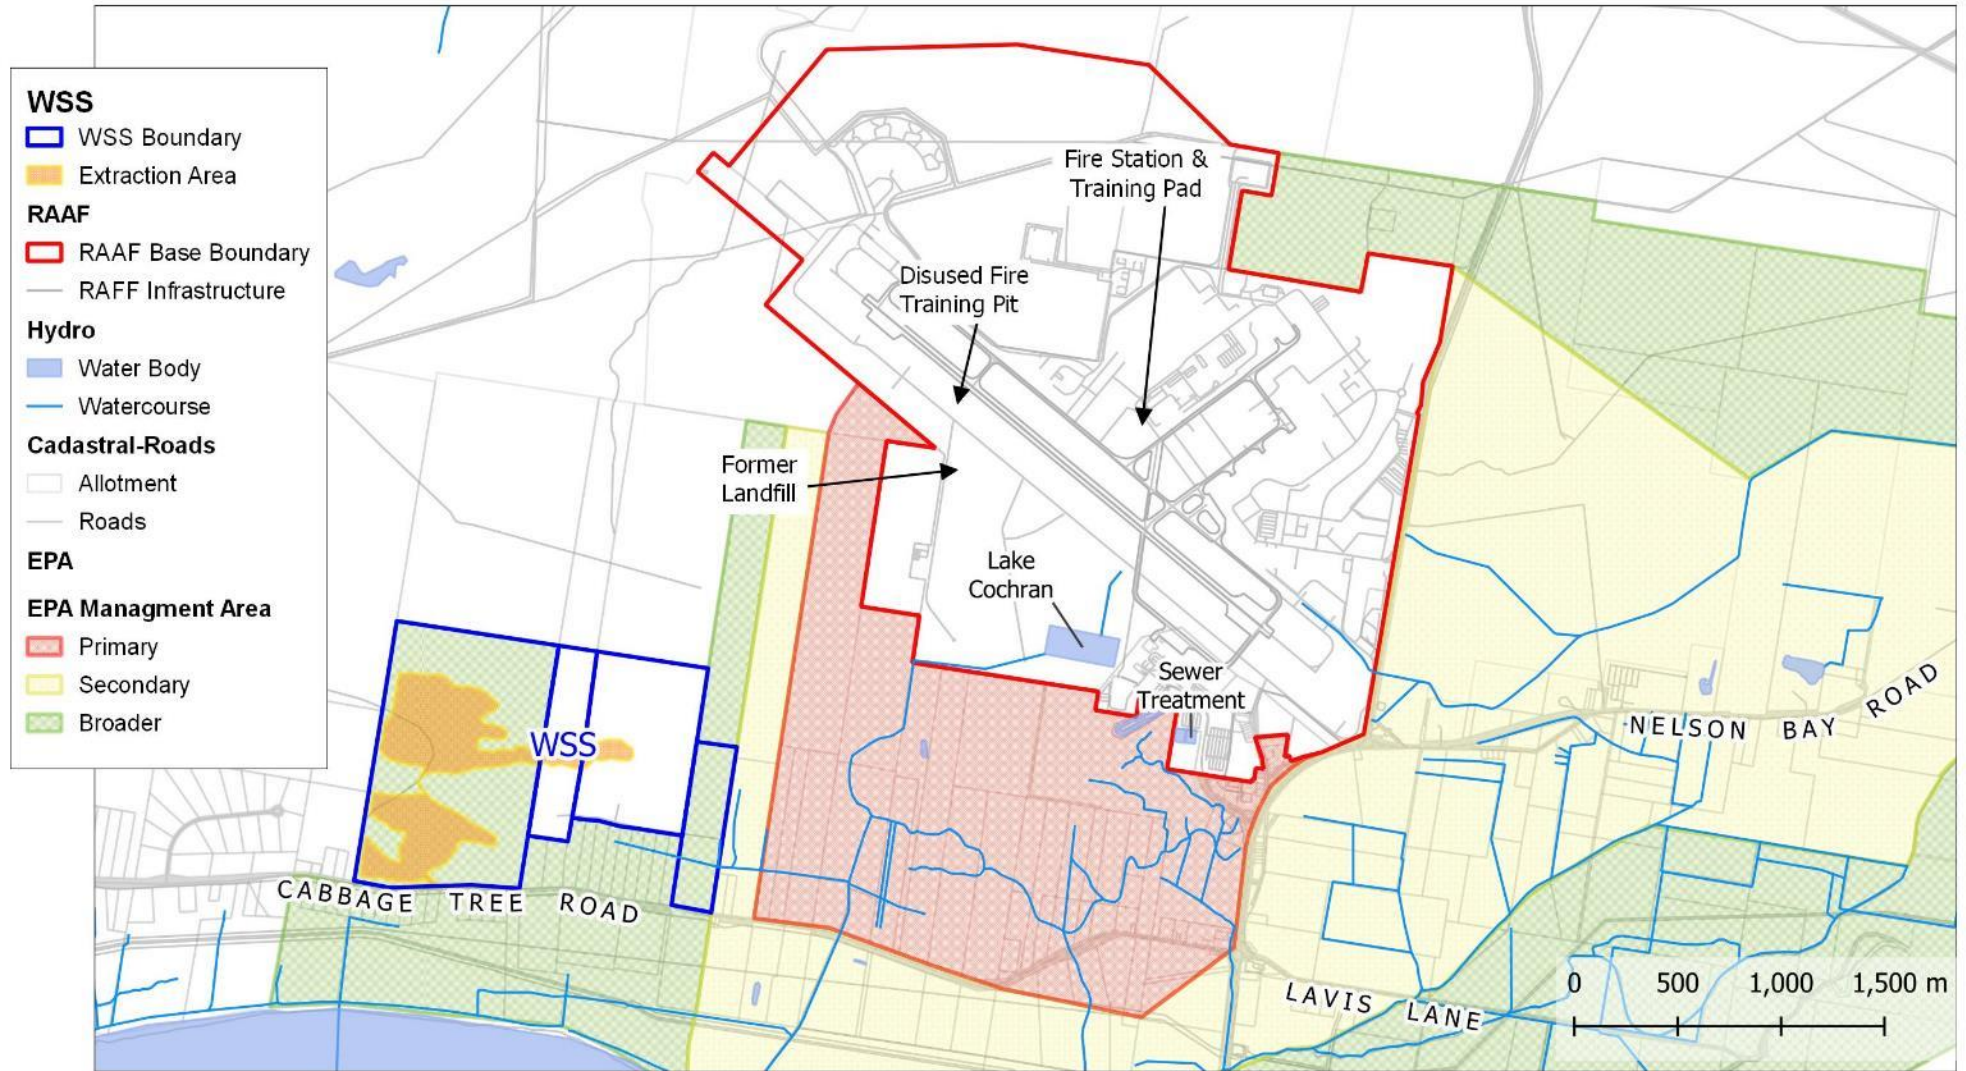
Figure 1. Site regional context.

Geologically the Site is located within the Tomago Sandbeds, a linear series of shallow sand dunes that cover approximately 200 km<sup>2</sup> between Newcastle and Lemon Tree Passage, that have a mean thickness of 20 metres<sup>1</sup>. The beds were deposited from the Hunter and Karuah rivers during a period of high sea level and overlies clay and rock. The aquifer is the Tomago Sandbeds, with the underlying clay and rock generally acting as a barrier to vertical groundwater migration. Groundwater hydraulic gradients detailed in the DoD 2022 report ([www.defence.gov.au/environment/pfas/Williamstown/publications.asp](http://www.defence.gov.au/environment/pfas/Williamstown/publications.asp)) indicate a potential southerly groundwater flow direction and with a groundwater mound present to the south of the onsite stormwater retention basin known as Lake Cochran (**Figure 1** and **Figure 2 below**).

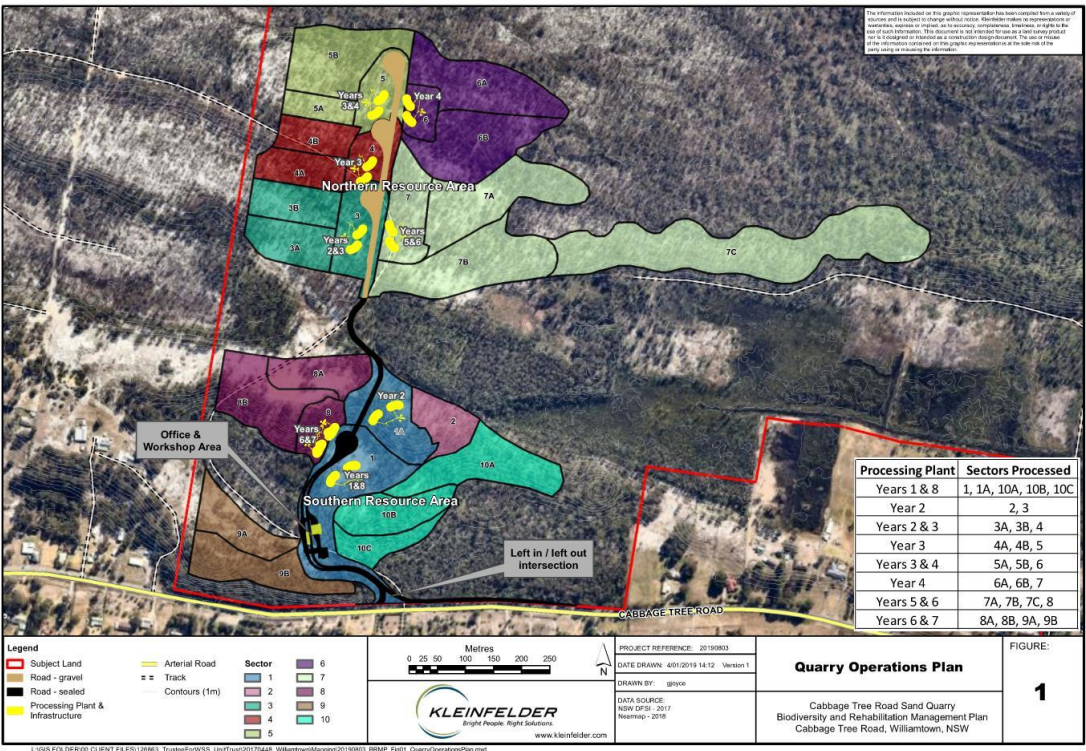
Figure 3: Quarry operations Plan

Various works have occurred at the Site throughout 2024 (see **Figure 3**). Quarrying operations proceed in pre-determined Sectors, which are mined sequentially based upon the scheduled mining operations procedures. Sectors are shown on **Figure 3** below. Mining operations area preceded by vegetation clearing of these areas and the sequential rehabilitation of previously mined Sectors. An initial wash plant was constructed within the central area of Sector 1 in July 2021. Construction of a second sand wash plant was completed in Sector 3 prior to the February 2023 annual monitoring round, with sand washing operations beginning in March 2023. Subsequently, the original wash plant has since been decommissioned and deconstructed. Monthly PFAS monitoring has continued at the new wash plant since it commenced operations.

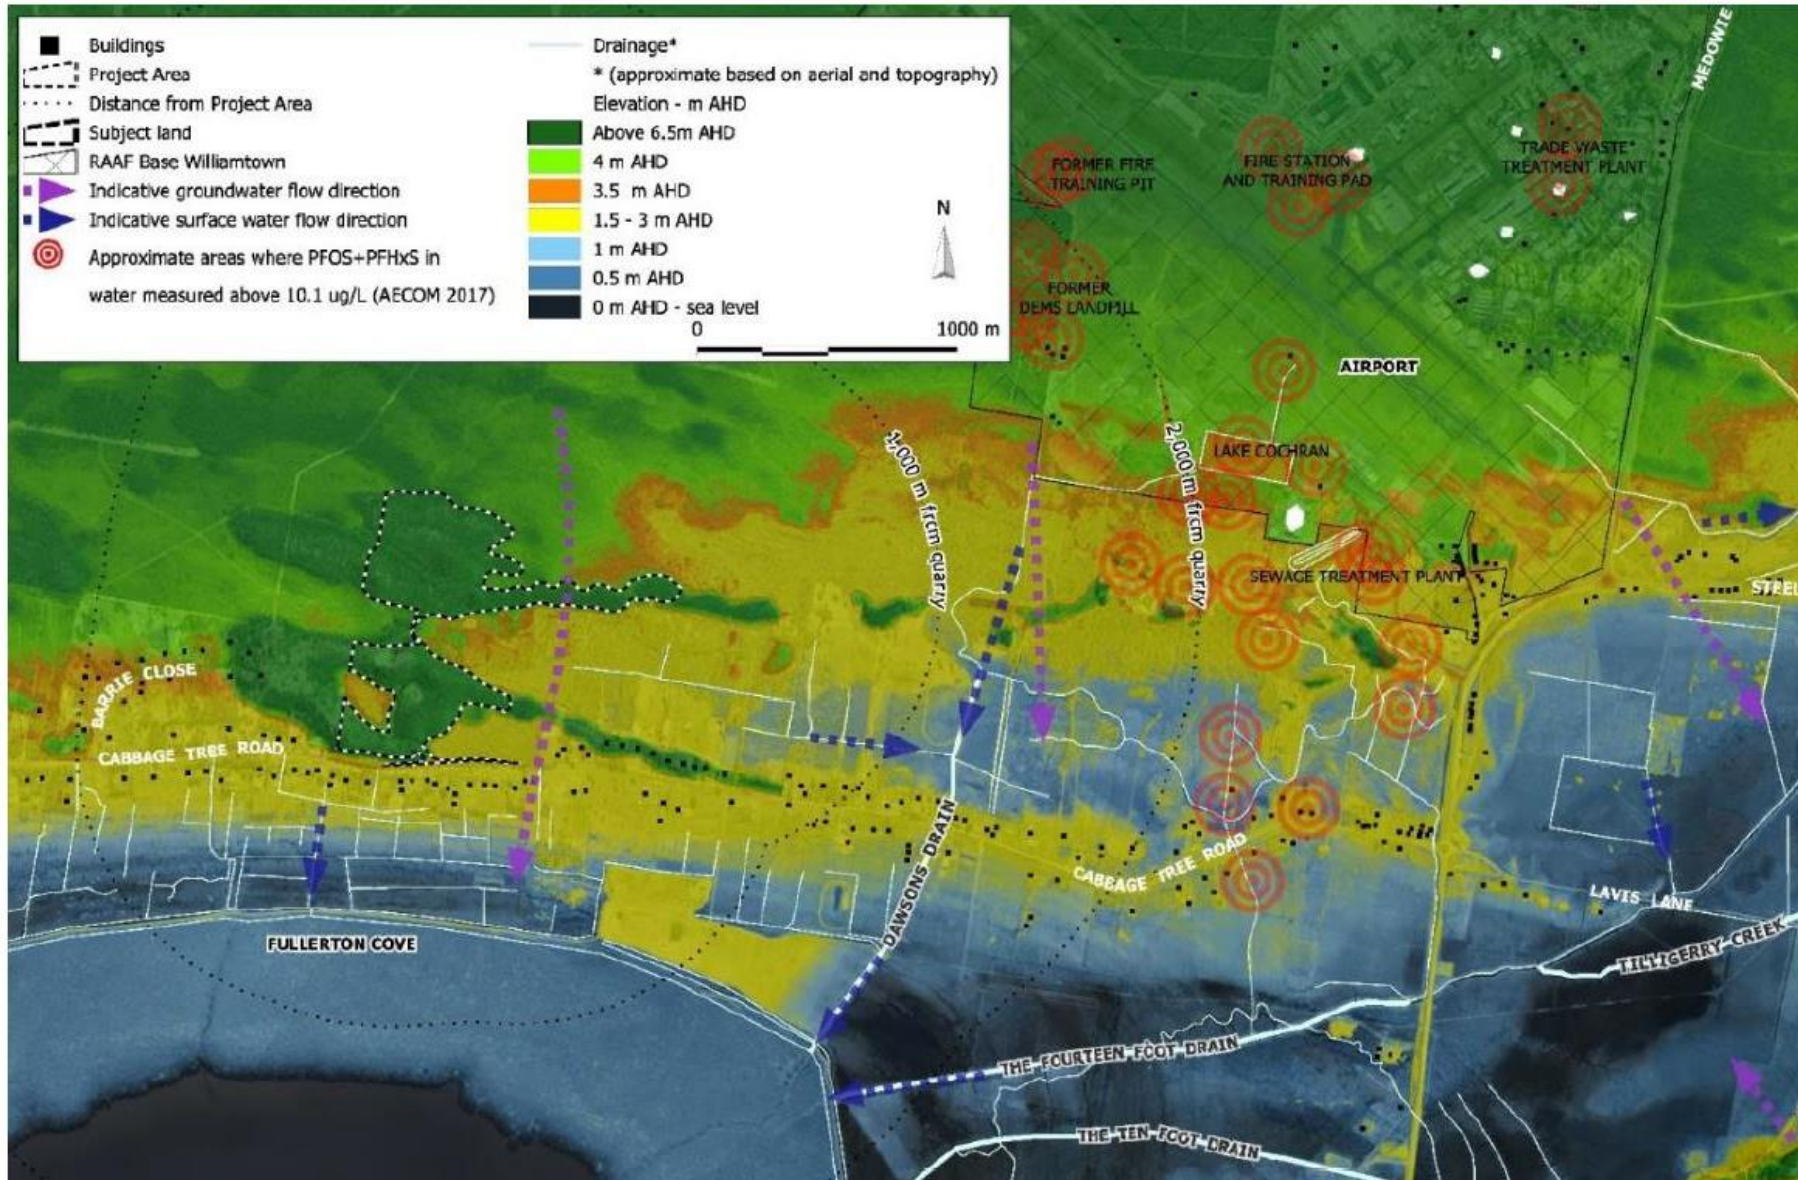
Figure 4: Elevation and drainage network of the project area and subject land in relation to surrounding lands.

The Site is not directly down-hydraulic gradient from any known primary or secondary Base PFAS source, as shown below on **Figure 4**.

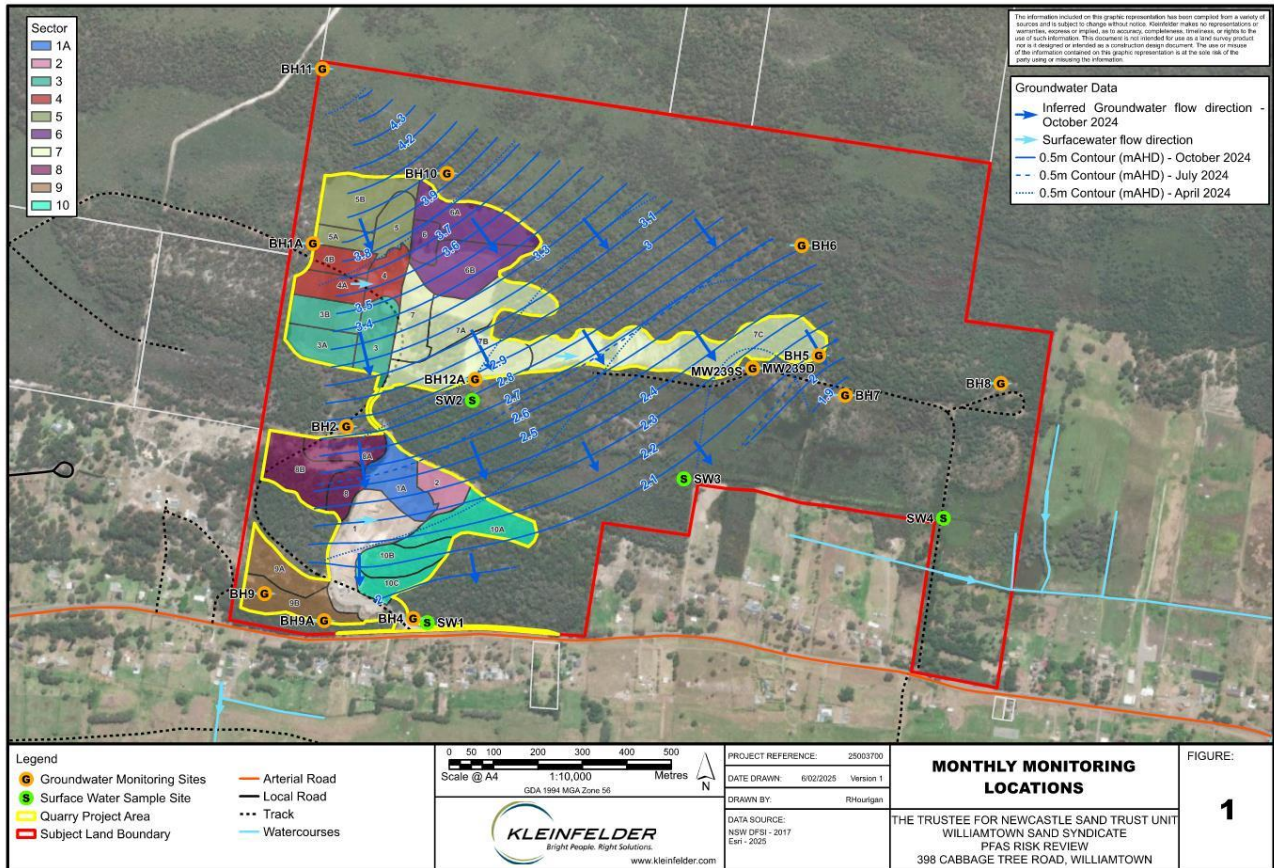
Figure 5: Inferred Groundwater flow direction through the Site during April, July and October 2024

During the 2024 monitoring period, groundwater elevations showed a stable to decreasing trend following on from the groundwater elevation trends reported between 2023 and March 2024 (Monthly Water Quality Monitoring reports, Kleinfelder, 2024) From April 2024 onwards, groundwater elevations reported a generally increasing trend across the site, peaking in July then falling during the latter part of the year (Monthly Water Quality Monitoring reports, Kleinfelder, 2024) There was an average increase of 0.12 m in groundwater elevation recorded when compared to the previous 2023 levels. The water table elevation contours indicate a southeasterly groundwater flow direction, as presented in **Figure 5**, consistent with the 2019 to 2023 contours.

Surface and groundwater sampling locations are shown on **Figure 5** below.

The potential groundwater flow direction, as depicted in **Figure 5**, is consistent with the observed 2020, 2021, 2022 and 2023 directions, from the northeast to the southeast through the site.
