APPENDIX 10. PRE-CLEARING AND CLEARANCE LETTERS

SUBJECT: Pre-clearance surveys and clearing works of Area 4a

ATTENDED NOISE MONITORING QUARTER 1 – MARCH 2022 Newcastle Sands Williamtown, NSW

APPENDIX 15. BIANNUAL REHABILITATION FLORA MONITORING

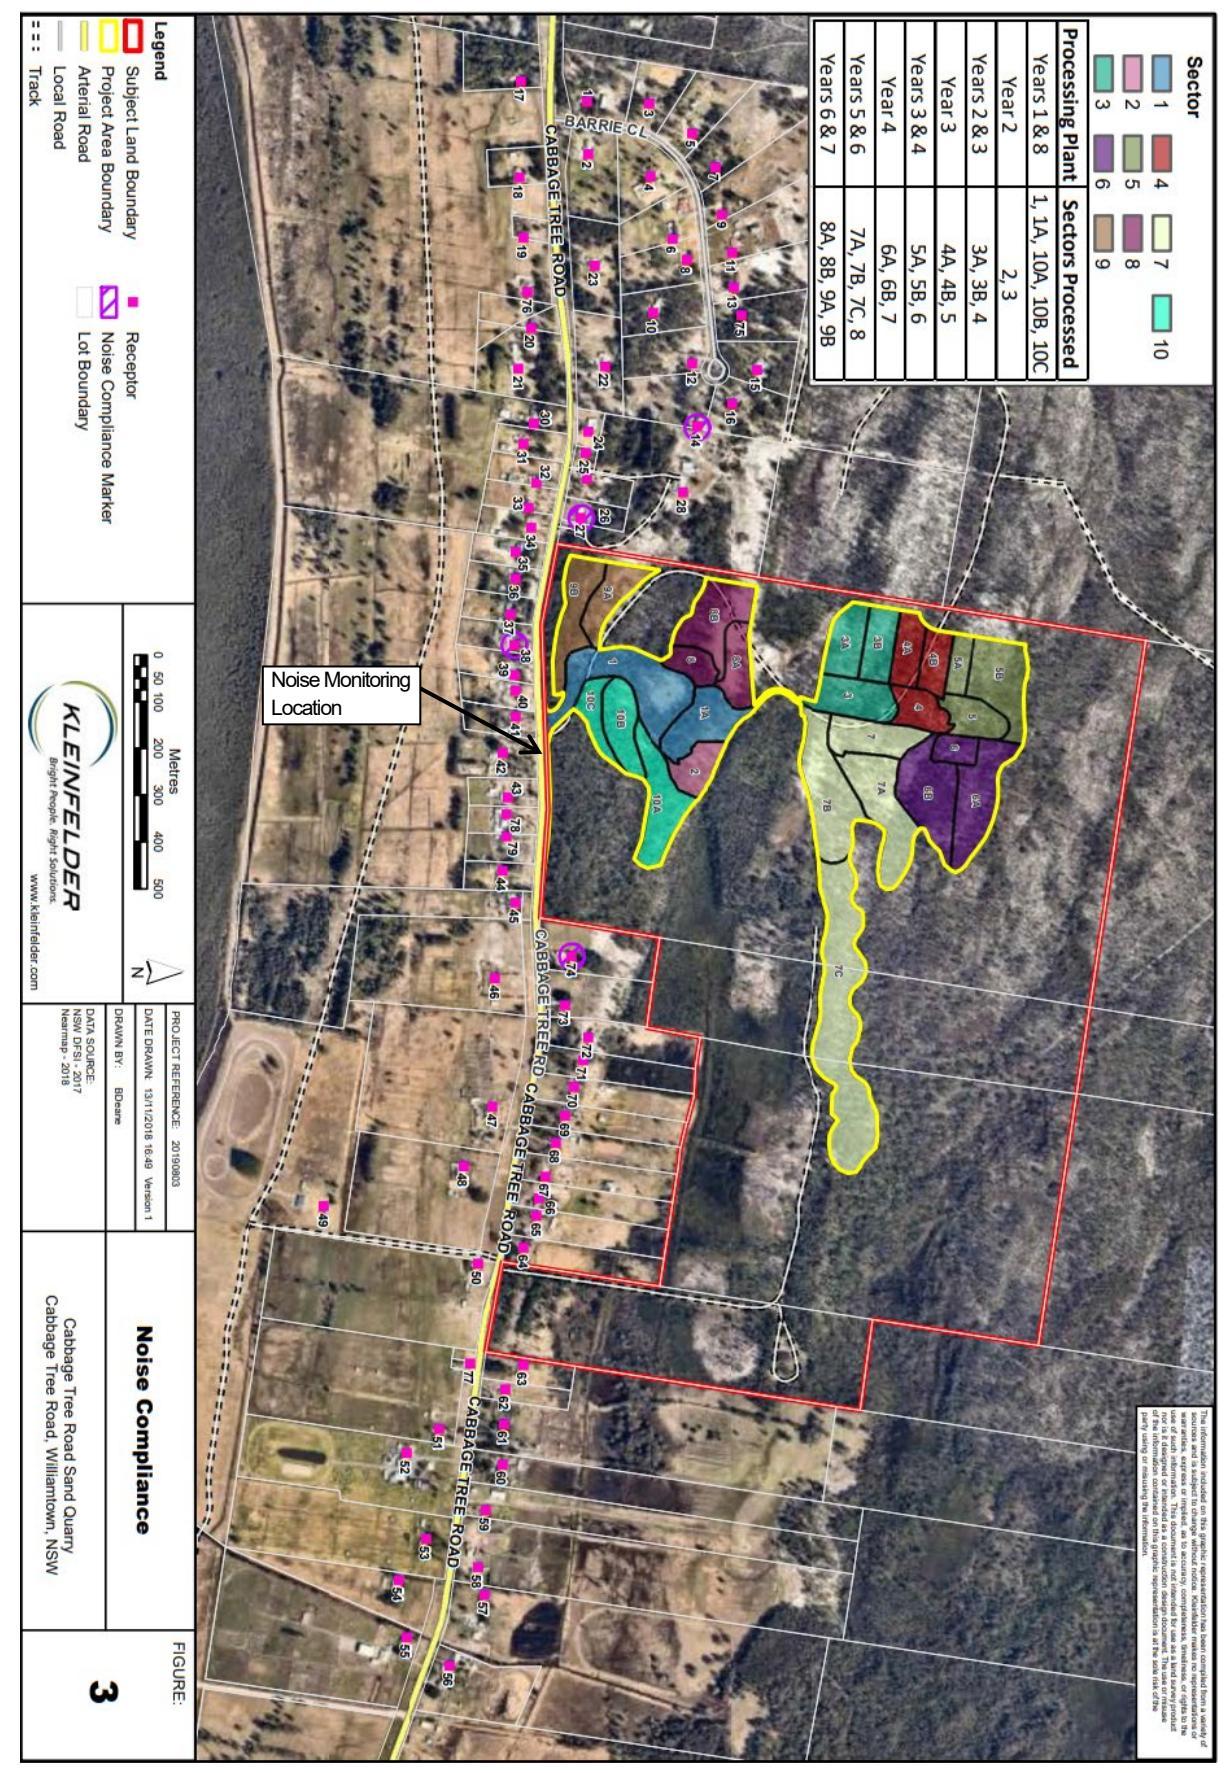
Figure 1 Noise Monitoring Location

Condition M8.1 of the EPL states that attended noise monitoring is to be undertaken at a location representative of the most affected residences in the noise limit conditions. Monitoring was conducted at receiver number 42 which is representative of receivers south of the site. The monitoring location is also shown on **Figure 1**.

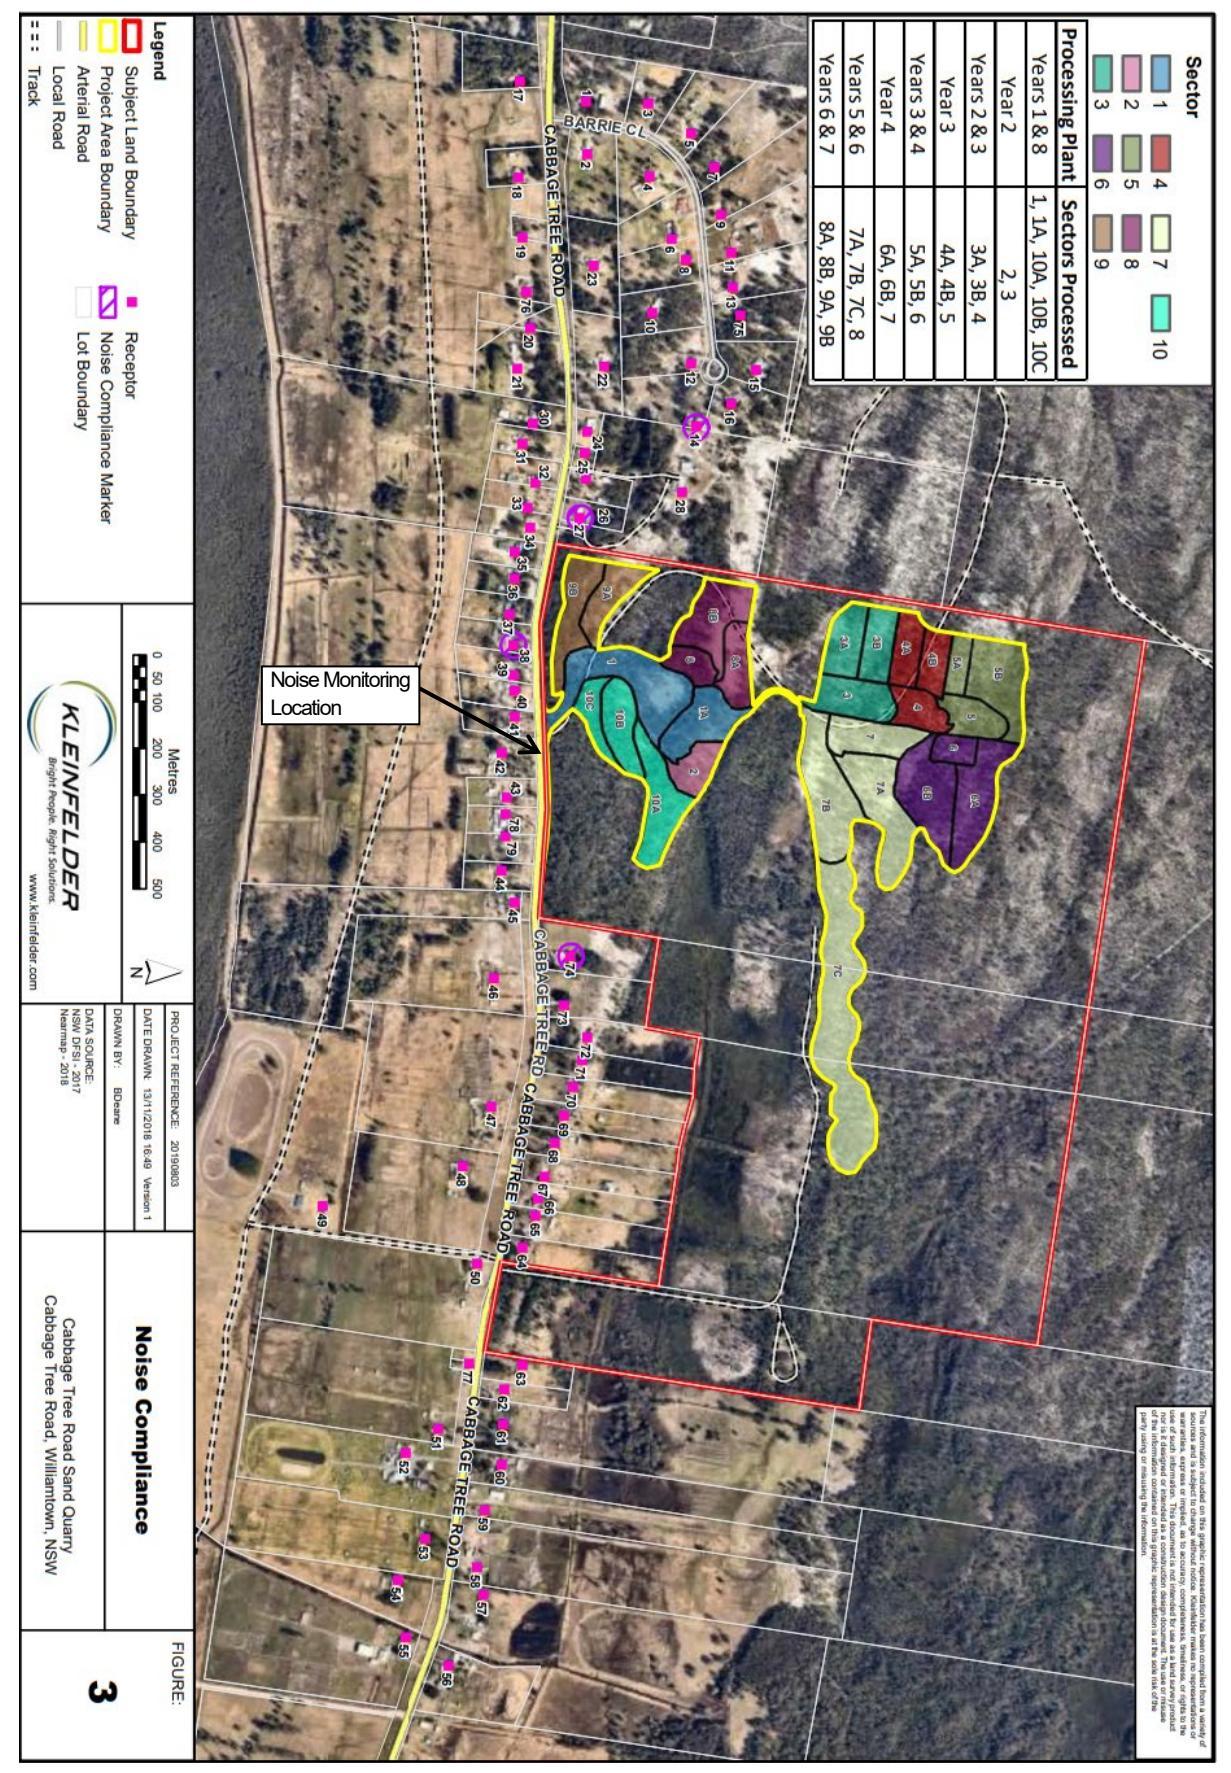
Figure 1 Noise Monitoring Location

Condition M8.1 of the EPL states that attended noise monitoring is to be undertaken at a location representative of the most affected residences in the noise limit conditions. Monitoring was conducted at receiver number 42 which is representative of receivers south of the site. The monitoring location is also shown on **Figure 1**.

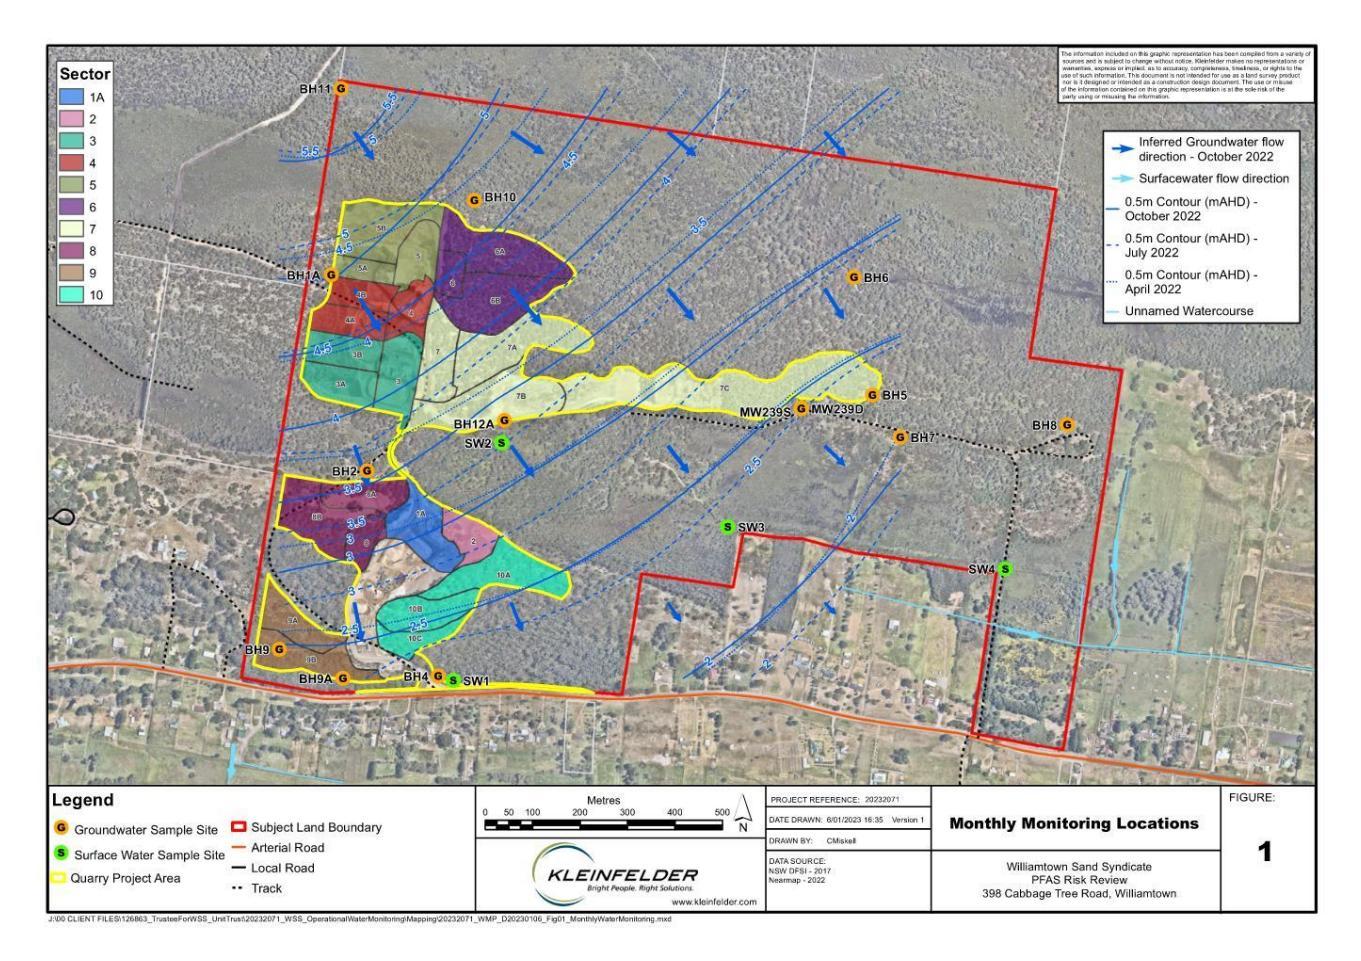
Figure 4: Inferred Groundwater flow direction through the Site during April, July and October 2022

During the 2022 monitoring period, groundwater elevation increased to a maximum measured level in July and was higher than historically recorded elevations measured on the Site. There was an average increase of 0.6 m in groundwater elevation recorded when compared to the previous July 2021 levels. The water table elevation contours indicate a southeasterly groundwater flow direction, consistent with the 2019 and 2020 contours (Error! Reference source not found.).

The floor of the quarry is based on maintaining a 0.7m buffer above the maximum predicted ground water level. There were thirty-two (32) instances of Trigger Action and Response Plan (TARP) trigger level exceedances during 2022, all occurring from March to December. This was following a rainfall total of 354mm in March 2022 and above average rainfall for much of the remainder of the year, recorded at the Williamtown RAAF weather station (# 61078). **Table 2** presents all TARP exceedances for 2022.

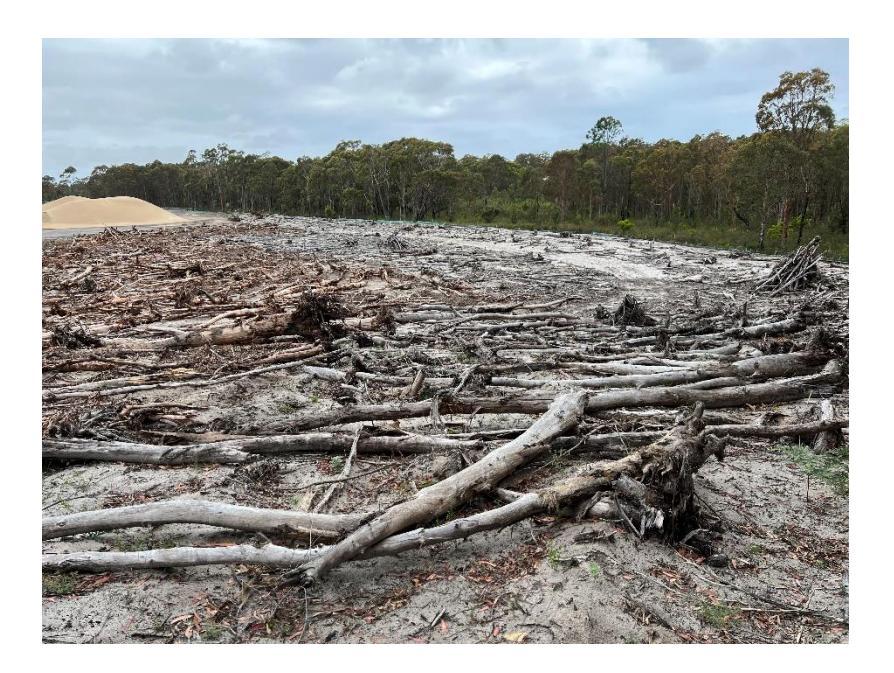
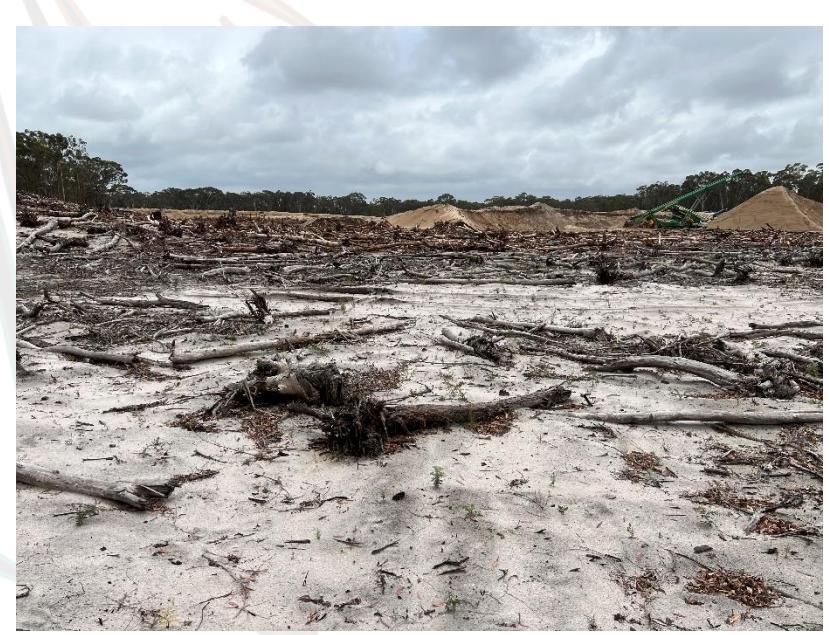
Plate 1: Sector 3A monitoring photos. Top PP1 looking SE, Bottom PP2 looking NE

Monitoring photos from the photo points show that this sector was in the very early stages of rehabilitation at the time of the survey (**Plate 1** and **Plate 2**).

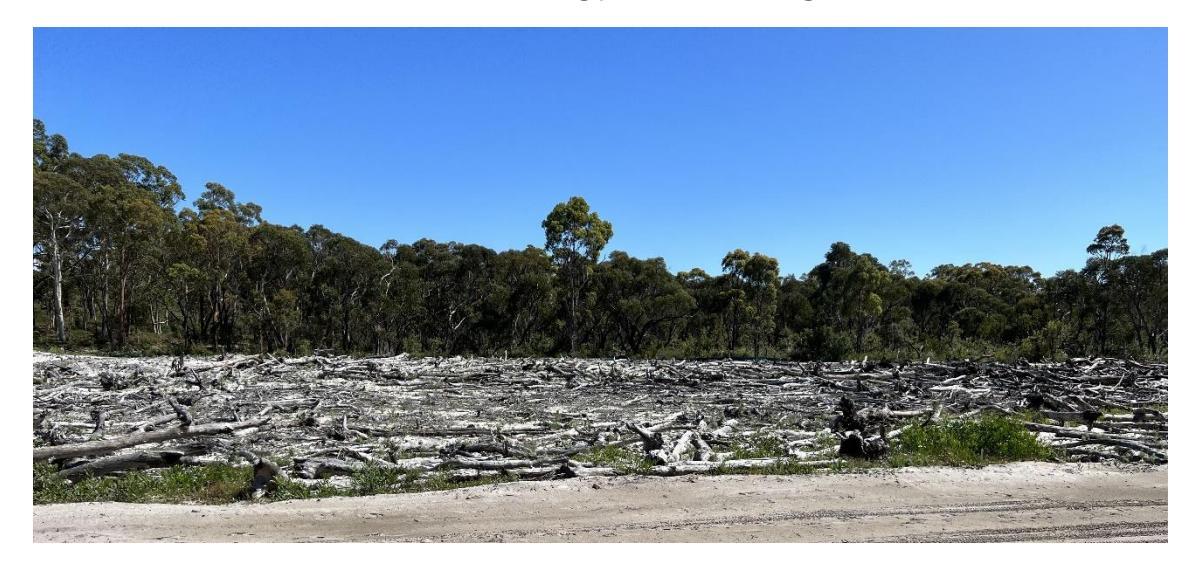
Plate 4: Expanded view of Sector 7B PP1. Note the *Acacia longifolia* sprouting along the edge of the haul road.

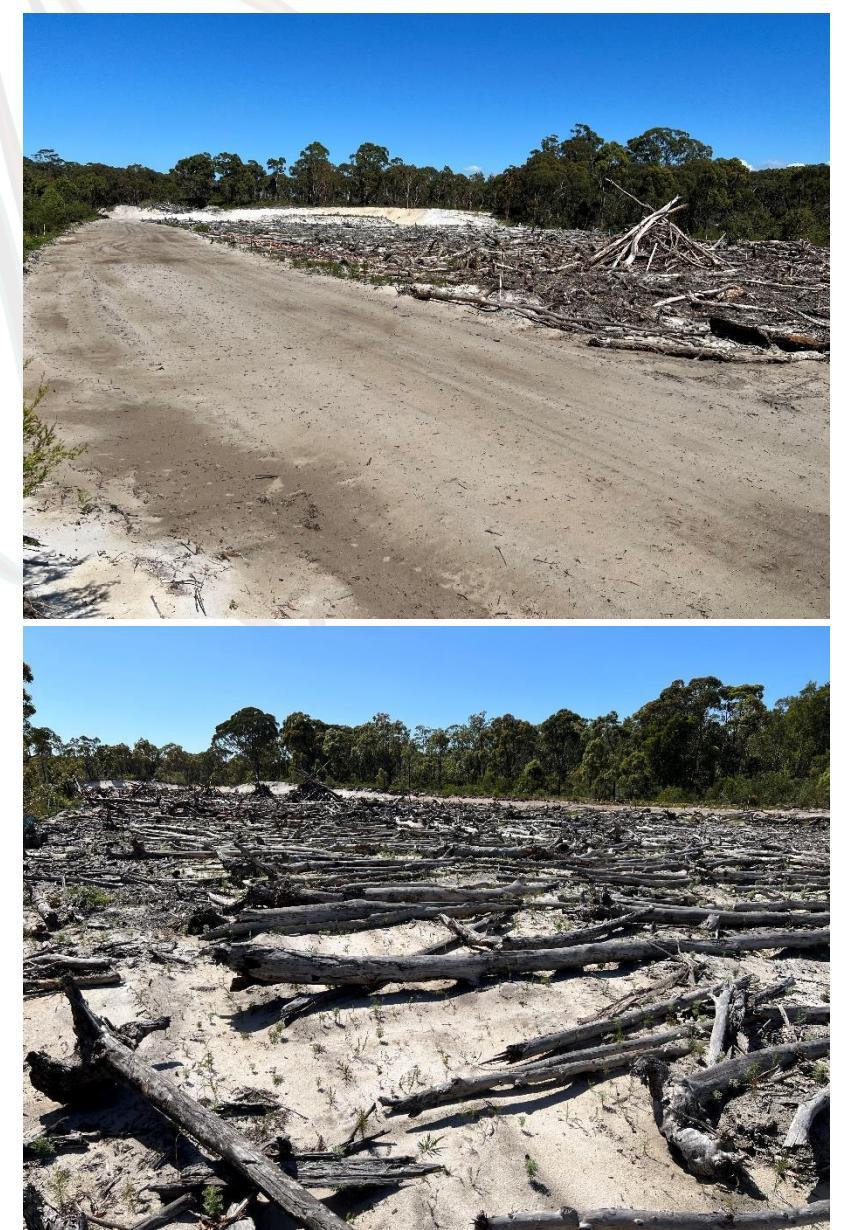
Plate 5: Sector 7B monitoring photos. Top, PP2 looking due west. Bottom PP3 looking SE. Note the small plants in the foreground.

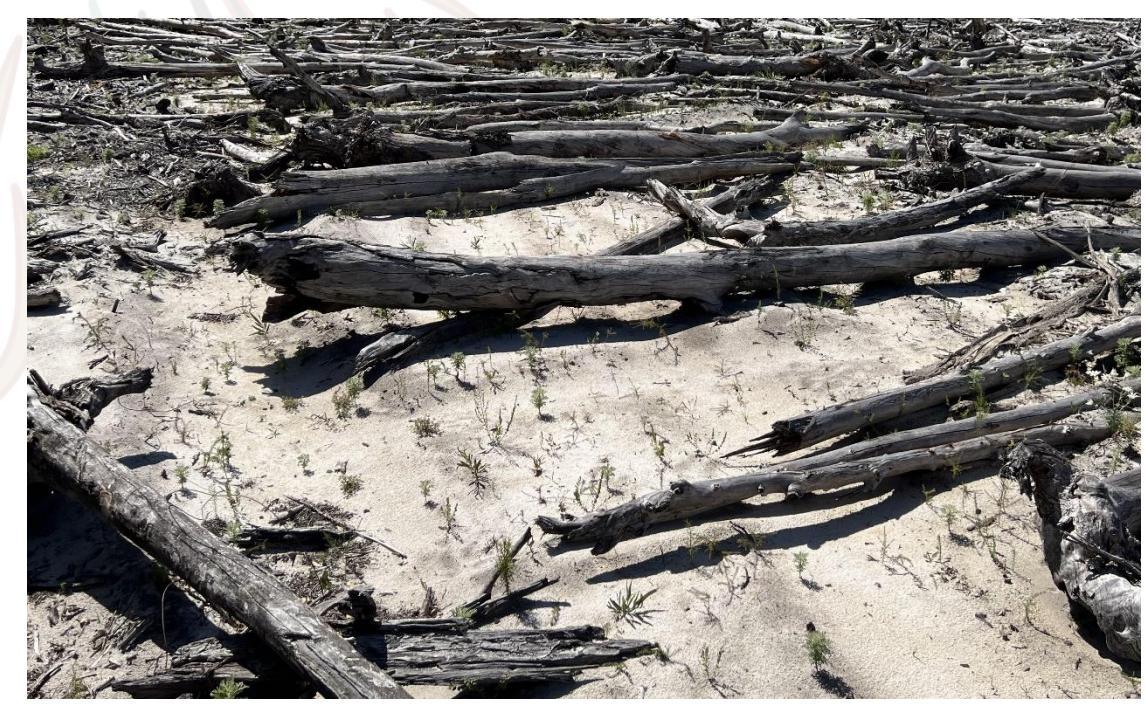
Ten of the twenty species (as per the BRMP) recorded were key species and in addition to the canopy species above included, *Acacia longifolia, Acacia ulicifolia, Actinotus helianthi, Bossiaea heterophylla, Dillwynia retorta, Hibbertia linearis, Lomandra longifolia* and *Ricinocarpos pinifolius.* Photo monitoring points of Sector 7B show that the revegetation is more advanced with vegetation growing along the haul road on the edge of the revegetation area (**Plate 3** and **Plate 4**). **Plate 5** shows the extent of the woody debris and the start of the natural revegetation, which is shown in more detail in **Plate 6**.

Plate 6: Sector 7B PP 3 close up showing the extent of the native flora in this sector.

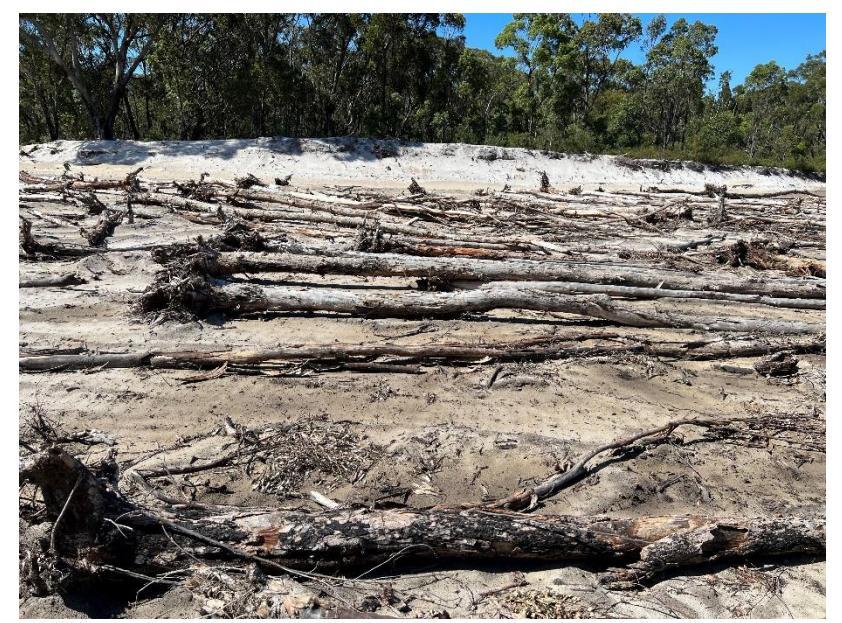
This sector was walked over to ascertain the stage of rehabilitation. Only a single plot recorded any vegetation. Two photo monitoring points were established which clearly demonstrate that vegetation had not yet germinated, and the next monitoring event would provide data for assessment (**Plate 7**)

Plate 7: Sector 7C showing this lack of vegetation at this early stage of rehabilitation
