Biodiversity and Rehabilitation Management Plan

Williamtown Sand Syndicate Pty Ltd

Cabbage Tree Road Sand Quarry
Cabbage Tree Road, Williamtown

1 April 2019

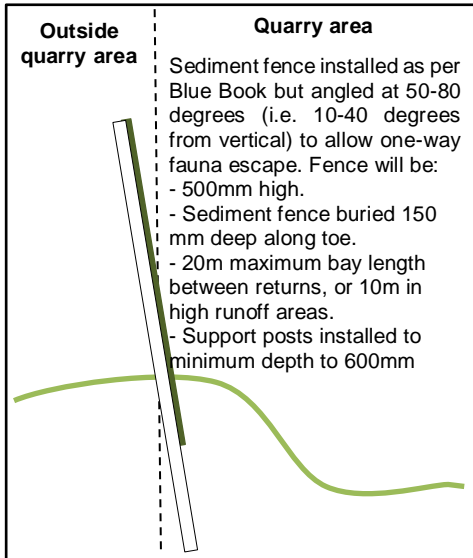
</div><p>Example of frog exclusion fence</p></div>	<p>Construction - install fence prior to or immediately following vegetation clearing.</p> <p>Year 1 onwards – install fence during December for the next 12 months of expected clearing.</p>	Quarry Manager	Nil
B	<ul style="list-style-type: none">Remove frog exclusion fencing where not required for sediment control on completion of extraction activities to enable access to rehabilitated areas.	On completion of extraction where not needed for sediment control.	Quarry Manager	Nil

Item	Action	Trigger/Timing	Responsibility	Reporting
6.4 FROG EXCLUSION FENCE				
A	<ul style="list-style-type: none">Sediment fence will be installed along the boundary of native vegetation areas for the purpose of excluding frogs from the active extraction areas that are stripped of vegetation and topsoil. Fencing may be relocated between each extraction area, where not required for erosion control. <div><div><div>Outside quarry area</div><div>Quarry area</div>

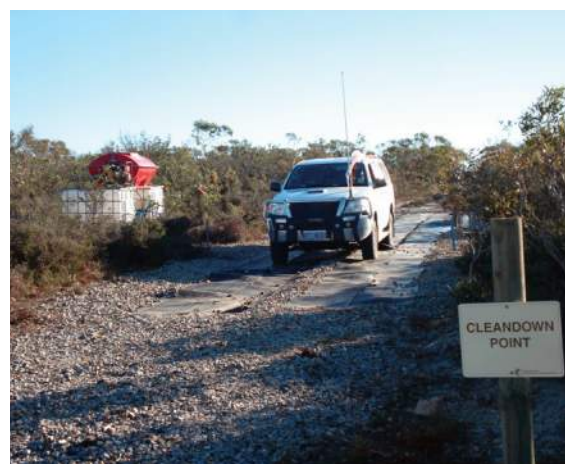
Photo: Wash-down point (Department of Parks and Wildlife WA)

- i. Use a wash-down facility for vehicles and machinery if available, or wash-down on a hard, well-drained surface, for example a road, and on ramps if possible. See **References and resources** below for links to online wash-down guidelines.
- ii. Pay particular attention to cleaning mud flaps and tyres.
- iii. Dispose of wash-down water so that it drains back into a low area of the infested zone away from waterways. If this is not possible, empty it into a waste container for responsible disposal offsite.
- iv. Don't allow wash-down water to drain into clean bushland.
- v. Don't drive through wash-down water.
